Contract #: 04-0120F4Cty: SF/ALA Rte: 80 PM: 13.2/13.9File #: 69.28**WELDING INSPECTION REPORT****Resident Engineer:**Pursell, Gary**Address:** 333 Burma Road**City:** Oakland, CA 94607**Report No:** WIR-003174**Date Inspected:** 16-Jun-2008**Project Name:** SAS Superstructure**OSM Arrival Time:** 700**Prime Contractor:** American Bridge/Fluor Enterprises, a JV**OSM Departure Time:** 1700**Contractor:** Zhenhua Port Machinery Company, Ltd (ZPMC), Changxing Island **Location:** Shanghai, China

Bridge No: 34-0006**Component:** Tower Mock-up**Summary of Items Observed:**

77M Partial Mock-up Macro Etch Evaluation

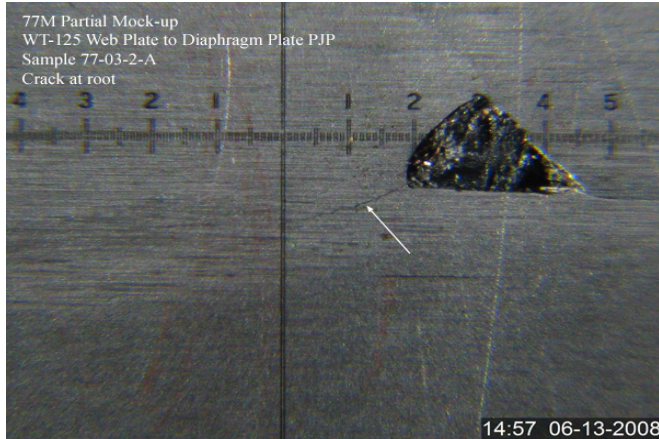
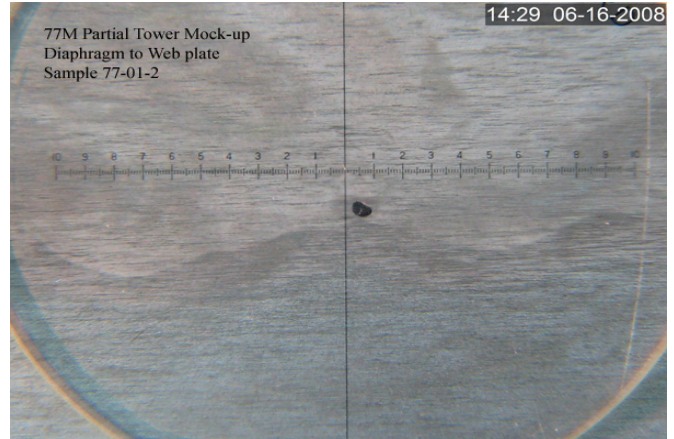
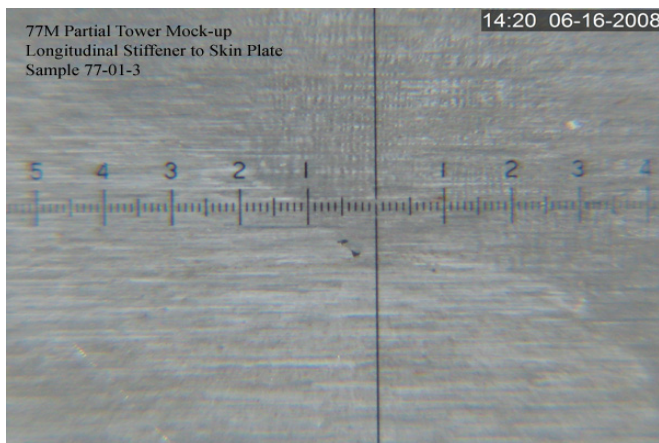
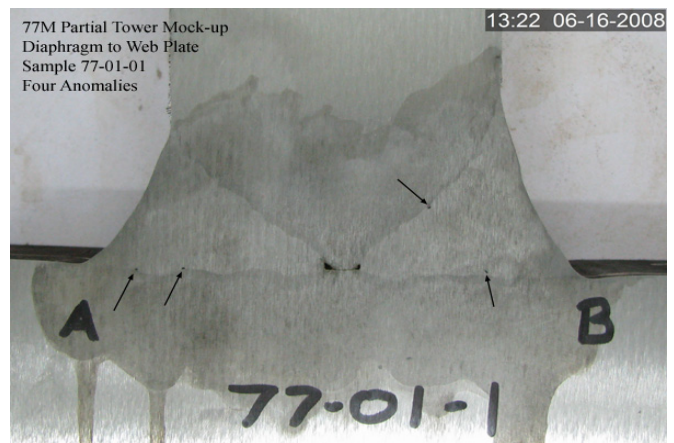
The Quality Assurance Inspector performed a review of the 77M partial mock-ups. There were three partial mock-ups representing the longitudinal stiffeners to skin plate connections, the diagonal stiffener to skin plate connection, and the diaphragm to web plate connection. Three samples were etched from each mock-up making a total of 15 welds. ABF Quality Control Inspector Xie Ping and ABF Representative Mike Williams evaluated the samples the previous day and stated that all samples comply with the contract documents. The Quality Assurance Inspector found three samples to be non-compliant. One for a crack and two for lack of fusion type discontinuities at a fusion boundry. The sample with what appeared to be a crack, identified as 77-03-2-A, Mr. Williams requested for the sample to be re-etched. After re-etching the sample appeared to comply with the contract requirements. ABF and ZPMC did not agree with the Quality Assurance Inspectors findings in regards to the two samples that contained lack of fusion at a fusion boundry, and requested that Caltrans Jim Merrill and ABF Steve Lawton get involved. Mr. Merrill reviewed the samples in question and after some discussion found the samples to be compliant. Below are digital photographs illustrating some of the sample discrepancies.
